# 17-year-old Warehouse Worker Crushed by Forklift

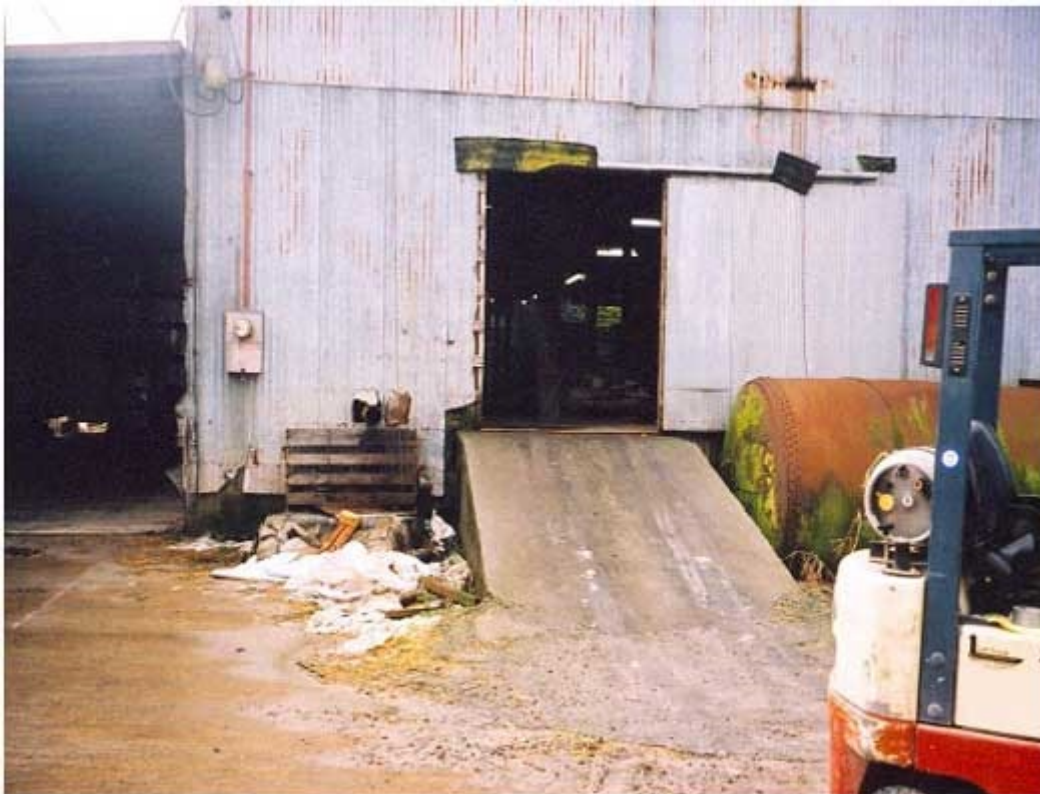
Photo 1

The incident happened at an agricultural cooperative (co-op). The co-op's retail store was connected to the co-op's tire shop and a warehouse. Also, on the grounds was an equipment storage shed, a fertilizer shed, and an outdoor storage area where 200-pound molasses animal licks were stored. A large flat concrete parking lot extended in front of the store entrance and around one side of the warehouse where a loading dock and ramp were located – Photo 1.

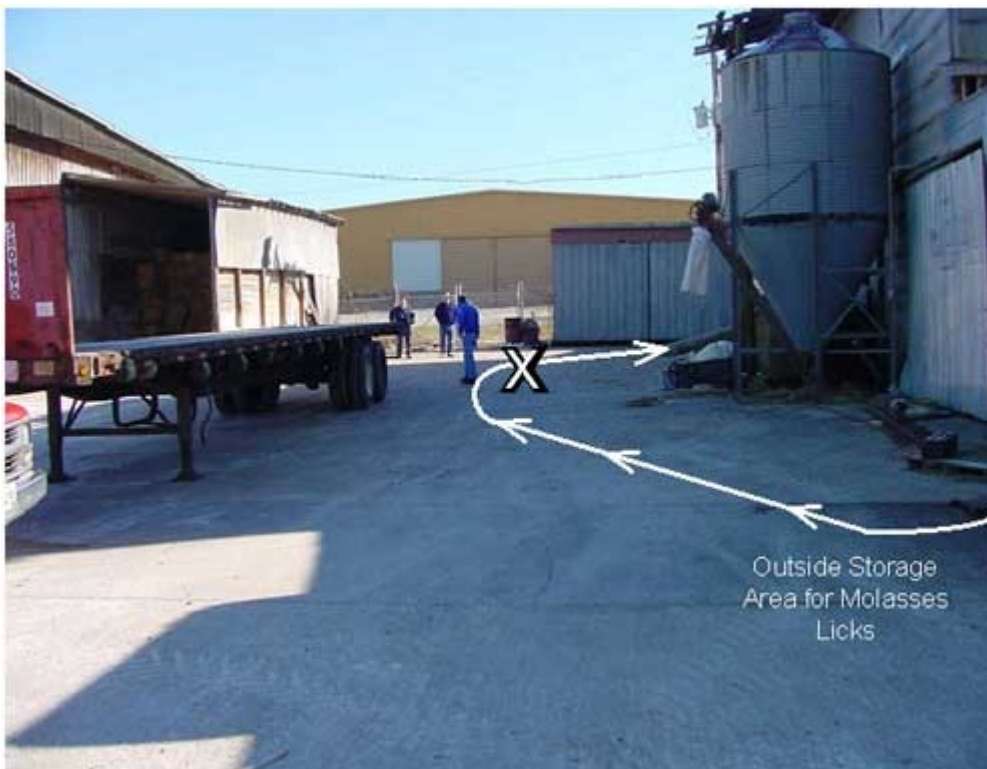
**Photo 2**

It appeared the victim was traveling toward the warehouse ramp on the level surface of the parking lot and made a sharp right turn to enter the narrow ramp leading up to the warehouse. It is surmised this is when the forklift tipped over onto its left side. The forklift was not loaded but its forks were raised approximately 20 inches. There was a single 12-foot skid mark located on the parking lot where it is surmised the victim started into a right turn toward the ramp.

Photo 2 illustrates the parking lot, warehouse and ramp, and other co-op buildings. Lines on the photo approximate the travel path of the forklift on the day of the incident. An "X" marks the approximate location of the forklift that had tipped over. Photograph courtesy of the Tennessee Department of Labor and Workforce Development, Division of Occupational Safety and Health.

The entrance/exit of the warehouse was narrow, measuring 70 inches in width. A post and an abandoned grain feed dispersal bin located inside the entrance left just enough room for the forklift to pass through.

- Old scrape marks on the forklift and on the post and grain bin inside the warehouse were likely indicators of a tight fit.
- The local manager said that forklift operators had to speed up to make it up the ramp and then had to slow down at the entrance to fit through the narrow passage after passing through the warehouse door.
- The ramp's surface was patched and rough where the ramp joined the flat, level parking lot.
  - The co-op was being relocated so the rough pavement in the transitional area where the level parking lot met the ramp, and the confined areas in the warehouse had not been changed because of the planned move.
  - It is worth noting these issues were known and identified as problematic.
- A well-developed safety and training program were lacking.

- Conduct periodic inspections and frequently remind equipment operators to use seat belts provided and never try to jump from an overturning sit-down type forklift.

- Check travel routes used by forklifts are free of obstacles and other unsafe conditions.
- Establish work policies that comply with child labor laws prohibiting youths less than 18 years of age from performing hazardous work, including operating power-driven hoisting equipment such as forklifts. All employees should be aware of this policy.
