Crushed-between Scissor Lift and Support Beam

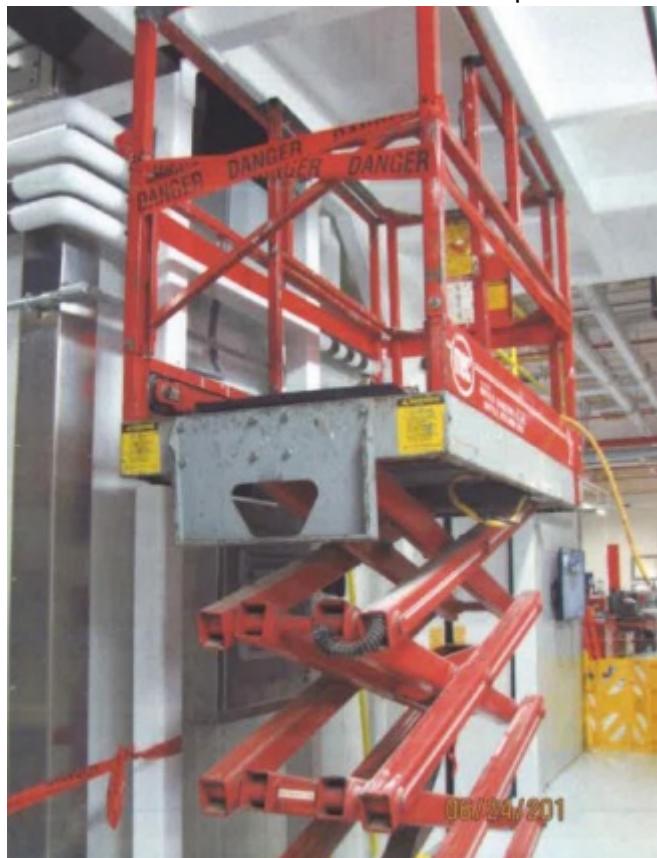
At some point while installing the insulation the victim became pinned between the

scissor lift upper guard rail and the bottom of the mezzanine outer support beam. During the investigation, it was determined that the control console on the scissor lift was missing the guard that prevents the inadvertent activation of the lowering and rising of the work platform.

The control console was found hanging on the opposite side of the lift from the

victim's work position. The most likely scenario is that the victim contacted the unguarded control console with his foot while trying to position himself leaning backwards out of the lift.

Had the guard been in place on the control panel and the victim not been working alone, it is likely this incident would have had a much different outcome. However, during the inspection it also was found the lower controls on the lift were not functioning, so it's possible that even if someone else was present they may not have been able to move the lift and free the victim in time.

This incident also highlights the importance of preventative maintenance and removing damaged or defective equipment from service until they are repaired or replaced.
