# Warehouse Supervisor Crushed by Pallet Stacking Machine

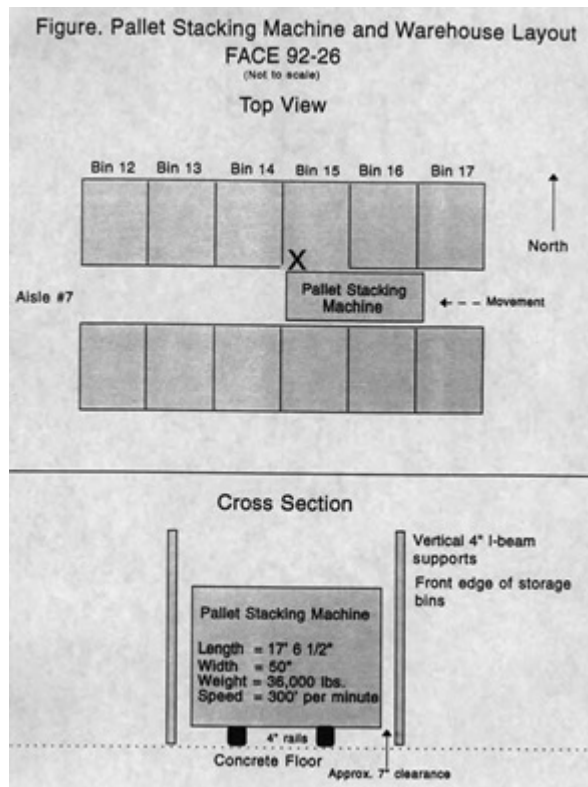
The clearance between the storage bins' vertical 4-inch I-beam supports and the stacking machine's metal frame was approximately 7 inches. The stacking machine was approximately 17-feet 6-inches long by 50-inches wide and weighed 36,000 pounds. The travel speed was about 300-feet per minute or 3½-miles per hour as it traveled in an east and west direction between the storage bins.

For unknown reasons the victim was in the aisle and had his back to the approaching stacking machine. It struck and crushed him between the stacking machine's frame and the storage rack's vertical support I-beam. His body was dragged several feet until some part of the victim's body contacted the bumper, causing the machine to stop.

- Creation of specific procedures to follow prior to any work being performed in the aisles. Including:
  - Locking and tagging the machine in the off position when personnel are in the aisles.
  - Retaining the key until all work is completed and the aisles are clear of personnel.
- Consider using two workers to perform any work in the aisles. One worker would be responsible for monitoring the movement of the machine while the other worker performs the task.
  - If the victim hadn't been working alone it is possible the second employee could have used the emergency stop which may have saved the victim's life.
- Consider installing stationary aisle warning lights and redesigning the stacking machine's pressure-sensitive stop bumpers.
  - Although the pallet stacking machine had green travel warning lights and

- Installation of stationary travel warning lights at conspicuous areas within the aisles.
  - Any time the machine is in operation, the stationary travel warning lights would illuminate to warn any worker in the area that the machine is in operation and to be alert to its location and movement.
- Redesigning the pressure-sensitive stop bumpers so an object located laterally, or adjacent to the machine, would contact the bumper causing it to stop.
  - The pressure-sensitive stop bumpers located on the front and rear ends of the machine, could only be activated by direct forward or rearward pressure on the bumpers.
  - An object which was positioned laterally, or adjacent to the direct line of travel (as was the case in this incident), would not engage the bumpers and stop the machine.
