# Accumulated Oxygen Sets Off Explosion in Steel Ladle

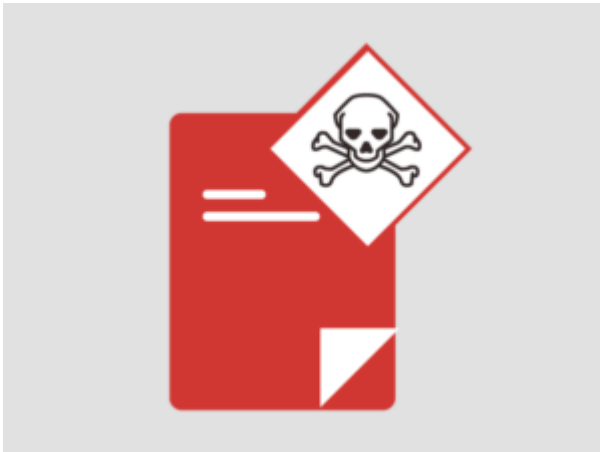
A man working in a steel plant was removing steel slag from the bottom of an upright ladle. He was using a jack hammer, a pry bar and a cutting torch fueled by acetylene and oxygen. The ladle was about 14 feet deep by 10 feet across. When he walked away from this task to take a coffee break, he left his equipment in the bottom of the ladle. When he returned 25 minutes later, he started to light the cutting torch to begin work again. An explosion occurred and the victim was engulfed in flames. A crane operator saw the incident and sounded his emergency horn, directing co-workers to the site. They poured water on the fire. The victim was taken to hospital where he died about three weeks later in spite of intense therapy.

On the day of the fatality, a number of things had been done differently from normal procedures. First, the worker had dismissed his helper who was supposed to be keeping a safety watch while he worked inside the ladle. Second, the ladle would ordinarily be tipped on its side with a plug removed from the bottom to improve ventilation, but this was not done. Third, the torch is usually removed from the ladle when not in use, but this time it was left inside during the worker's break. The torch was later found to be leaking oxygen. It appears that the leaked oxygen accumulated in the ladle ? a confined space ? and was ignited when the worker started the torch to resume work. Following correct procedures such as keeping the safety watch, checking the atmosphere in the ladle before lighting the torch, and wearing fire retardant clothing might have helped to prevent this fatality. Never forget that safe work procedures are there for your protection. Rules requiring ventilation when using oxygen and fuels are intended to prevent tragedies such as this one.
