Fatalities in the Oil and Gas Industry

Crew stays clear of runaway spool

Ignoring lockout procedure injures motorman

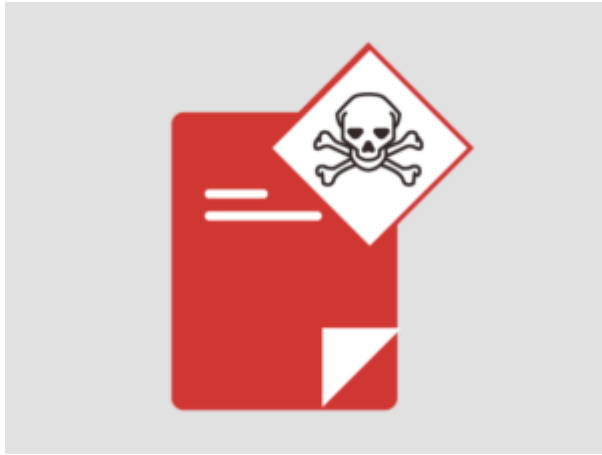
A drill crew was in the process of slipping and cutting a 1-3/8 drill line. Two floormen were assigned to un-spool wire rope until there was approximately a 40-foot loop below the storage reel.

As the drill line reached the desired slack, the spool continued to rotate due to its momentum. An attempt was made to stop the rotation by using a wooden board as a brake lever.

When it became evident that it wasn't possible to stop the spool from rotating, all personnel were instructed to vacate the area and stay clear.

The drill line eventually became entangled, which stopped the rotation of the spool. Fortunately, there were no injuries.

- Manually un-spooling the drill line from the spool prior to slipping the drill line.
- The drill line spool was not driven by a powered device.
- The drill line spool was not equipped with a mechanical braking device.
- A relatively full spool of drill line was in use and the momentum of the rotating spool was too great to be stopped manually.

To address the incident, the company developed a standard drill line spool drive and braking system.

- Reviewing and revising the job safety analysis for the task of slipping and cutting drill line
- Ensuring the drill line spool is equipped with a mechanical braking device
- Confirming the mechanical braking device is maintained and working properly
