Floor Openings Picture This

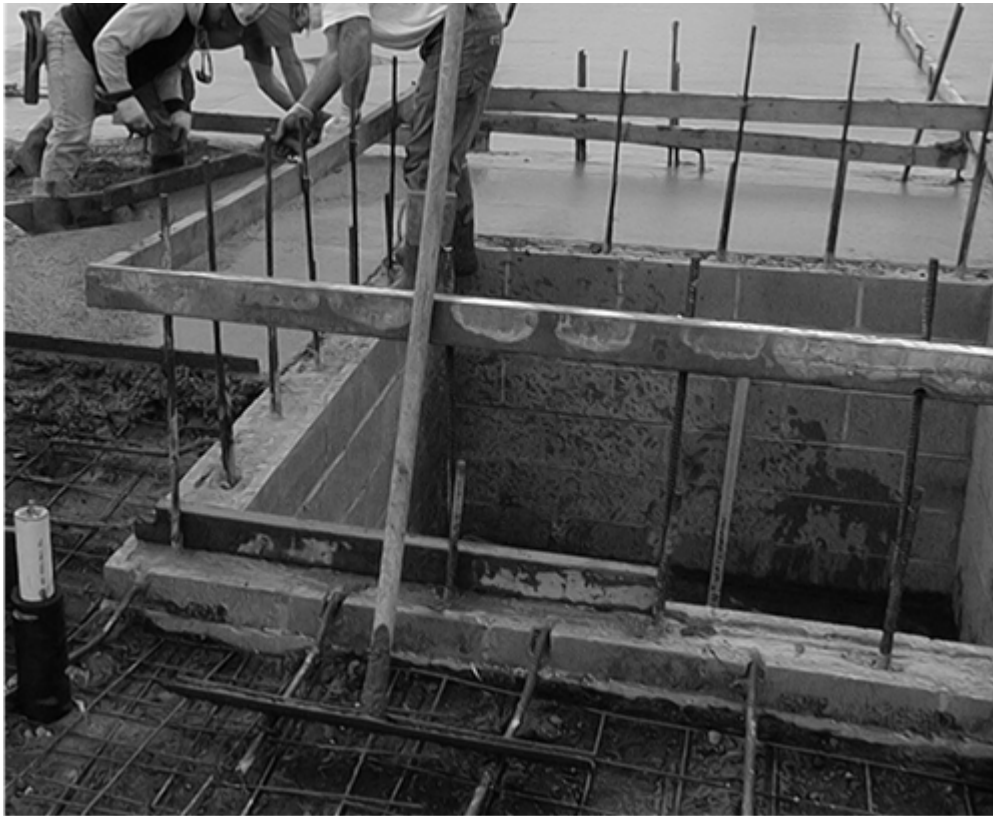
The railing arrangement in this photo is in some ways more dangerous than the floor hole it's guarding:

- There's no intermediate railing; and
- The post ends jutting out from over the top railing are uncapped and could cause serious damage if workers stumble into them.

Moral: Make sure your floor hole guarding arrangements meet OSHA standards and don't expose workers to additional hazards.
