Is This a Safe Way to Guard a Floor Opening?

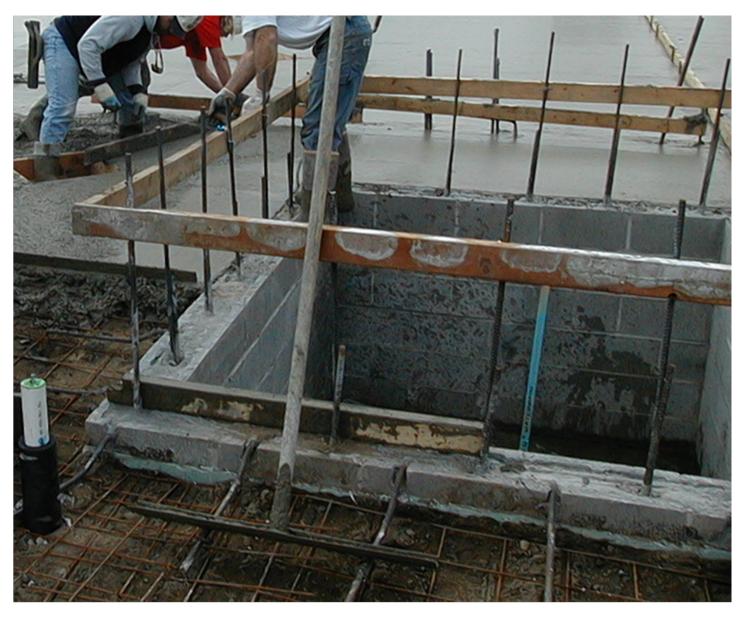
What is wrong with this picture?

The railing arrangement in this photo is in some ways more dangerous than the floor hole it's guarding:

- There's no intermediate railing; and
- The post ends jutting out from over the top railing are uncapped and could cause serious damage if workers stumble into them.

The railing in this photo is clearly not up to "standard."

Moral: Make sure your floor hole guarding arrangements meet OSHA standards and don't expose workers to additional hazards.

MAKE SURE FLOOR HOLES ARE PROPERLY GUARDED

OSHA (Sec. 1910.23(a)(8)) says that floor openings must be guarded by EITHER:

1. A Floor Hole Cover of standard strength and construction;

2. A Standard Railing and Toeboard on all exposed sides.

According to OSHA (Sec. 1910.23(e)(1)), there are 5 things a railing must have to be considered "standard railing":

- 1. A top rail that's smooth-surfaced throughout the length of the railing;
- 2. An intermediate rail that's located about halfway between the top rail and floor/platform/runway/ramp;
- Posts;
- 4. At least 42 inches in height measured from the upper surface of the top rail to

the floor/platform/runway/ramp;
5. Ends of rails that don't overhang the terminal posts (unless the overhang
doesn't constitute a projection hazard).
