Is This a Safe Way to Guard a Floor Opening?

What is wrong with this picture?

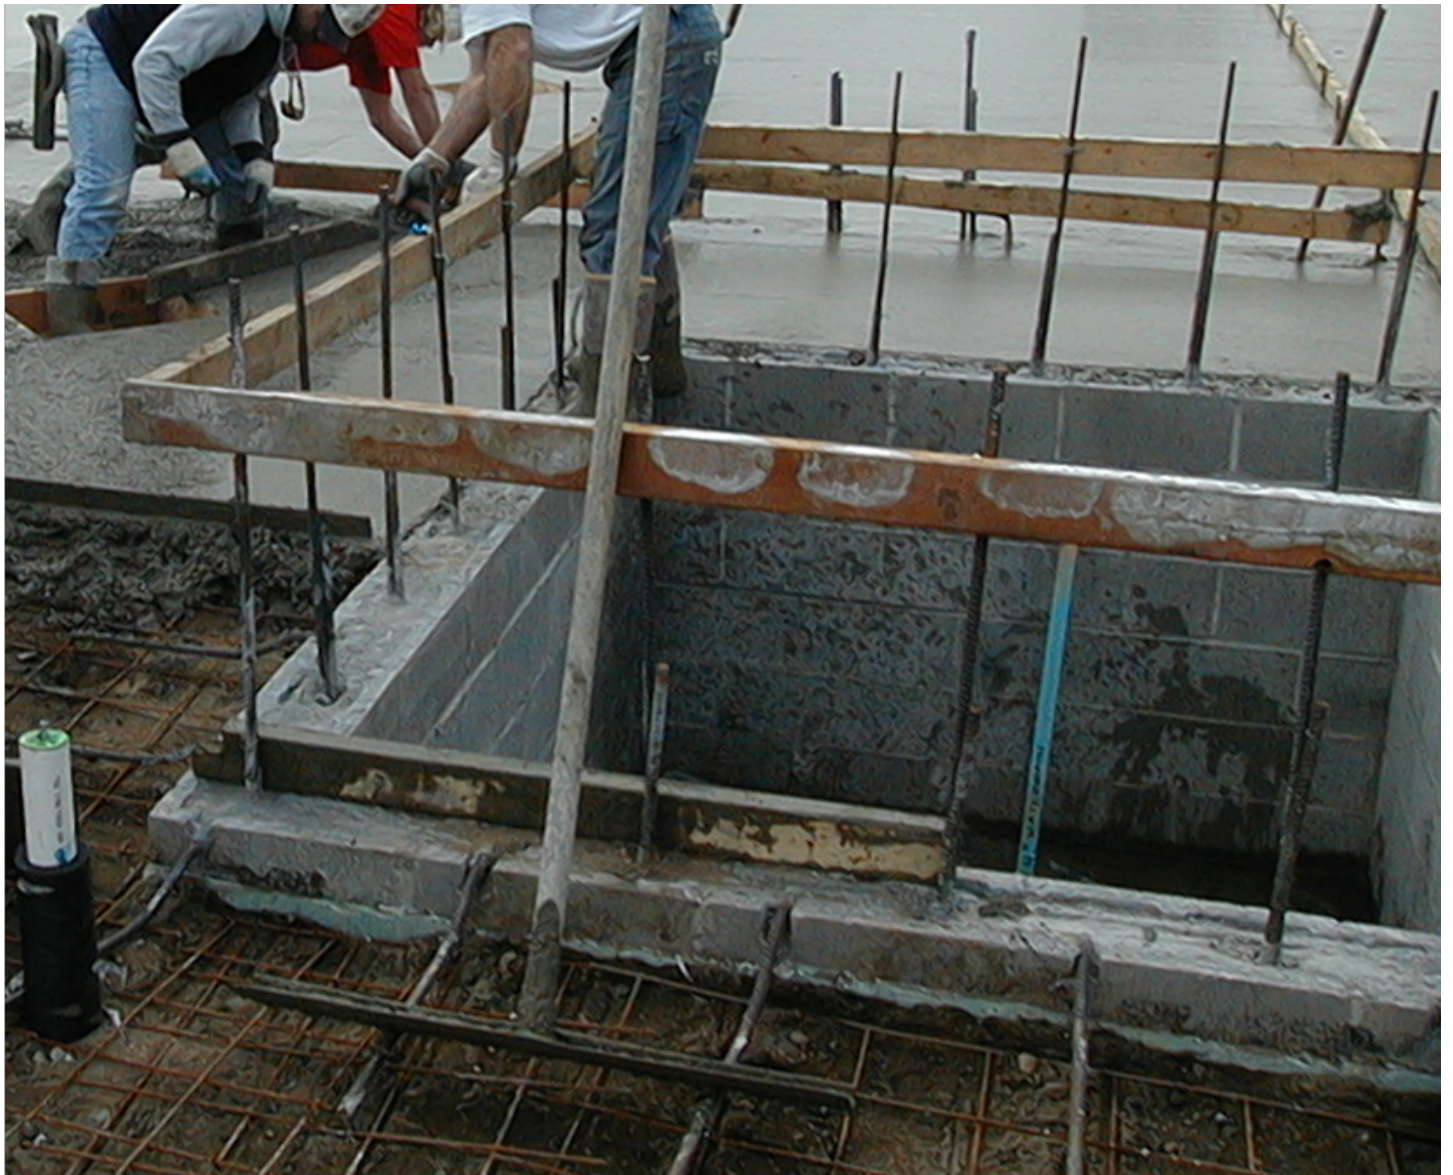
The railing arrangement in this photo is in some ways more dangerous than the floor hole it's guarding:

- There's no intermediate railing; and
- The post ends jutting out from over the top railing are uncapped and could cause serious damage if workers stumble into them.

Moral: Make sure your floor hole guarding arrangements meet OSHA standards and don't expose workers to additional hazards.

The railing in this photo is clearly not up to "standard."
