# Upper Boom Failure on Aerial Lift

## Incident Summary

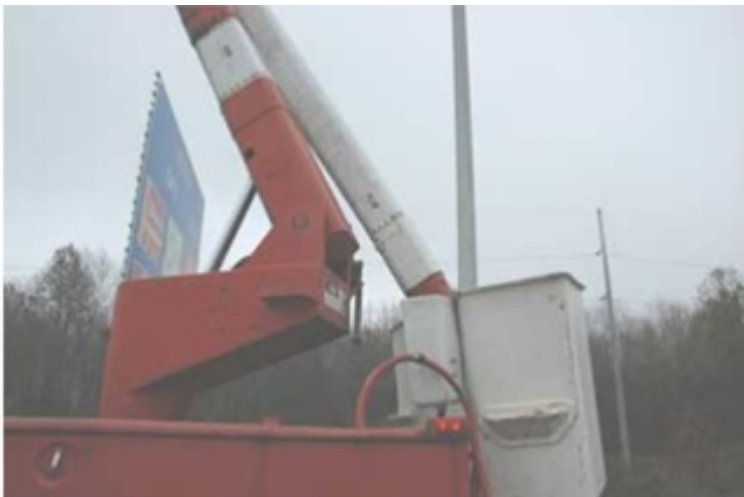
A 45-year-old owner of an electrical contracting company died after falling 9 feet to the road when the articulating boom of the aerial lift truck he was working from collapsed (photo 1).

Photo 1: Aerial lift boom after incident. Note that the lower boom section remains elevated while the bucket-end of upper section is in a lowered position (photo courtesy of OSHA).

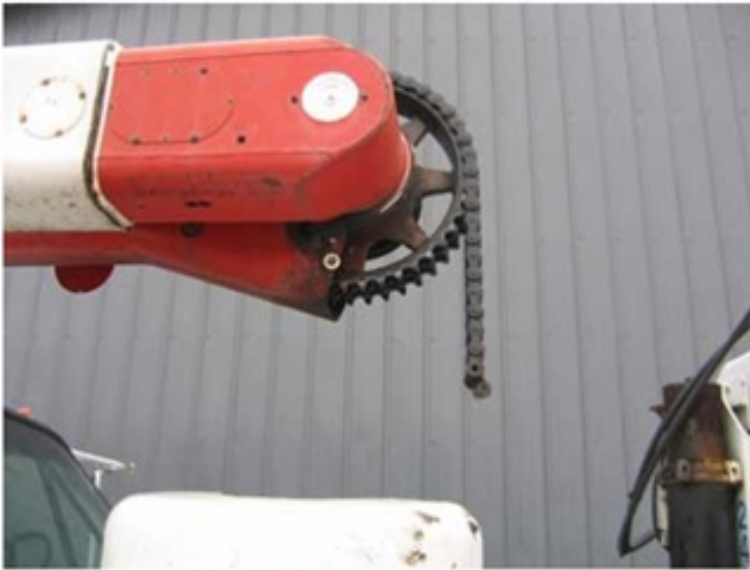
Post incident inspection of the articulating boom revealed the boom actuating chain had separated resulting in the catastrophic collapse of the upper boom (photo 2).

Photo 2: Broken boom actuating chain (photo courtesy of OSHA).

It appears lack of proper lubrication of the chain is likely what caused the chain to break. This incident highlights the significance of:

1. Reading and adhering to the manufacturers' recommended maintenance schedule. The operation and maintenance manual detailed maintenance recommendations, procedures and warnings.

- In particular, the manufacturer recommended the roller chains, including the upper boom actuating chain, be lubricated every 30 days.
- A warning in the manual stated a lack of lubrication can cause galling and corrosion of the chain pins; breakage of the pins; and result in free fall of the upper boom (photo 4).

- The operation and maintenance manual recommended regular maintenance and inspections to include – the upper boom actuating chain for lack of lubrication, broken rollers and pins.
- It also stated lack of lubrication is indicated by squeaking or groaning noises when the booms are moved.
- The recommended inspection/maintenance frequency for pulleys, sprockets, pins and chains is monthly. A major overhaul of the unit was recommended, according to average use, after 3 years or 6,000 hours of use, whichever came first
  - The aerial lift involved in this incident was 18 years old.
  - There was no record of maintenance and inspection having been performed on the boom structure or other assemblies of the aerial lift.

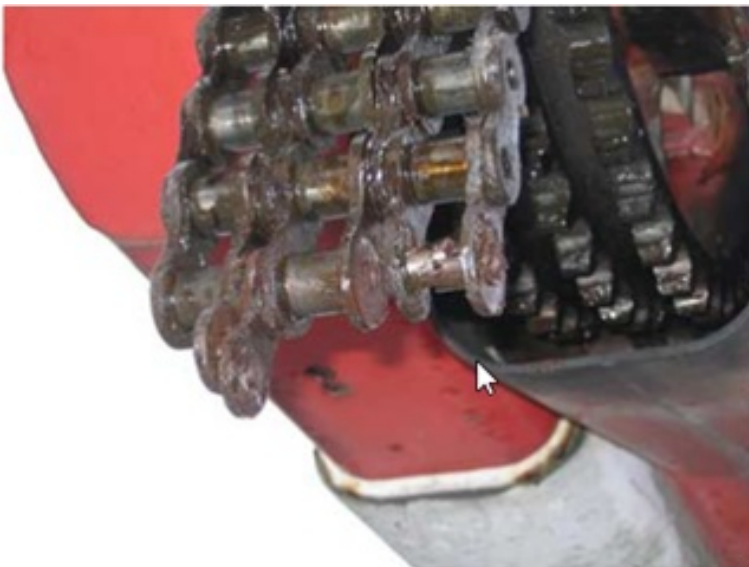
Photo 4: Broken section of boom actuating chain  
(photo courtesy of OSHA).

2. Pre-use inspection and removing suspect equipment from service until has been made safe to use.

3. Regular maintenance and inspection by a qualified person.
