# Welder Falls 19 Storeys

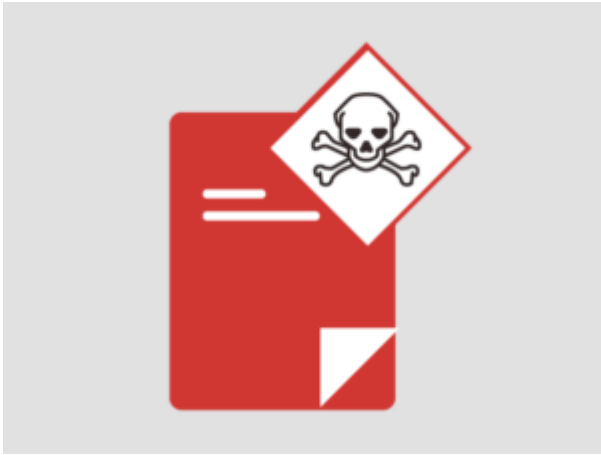
A welder with 20 years' experience as an iron worker died after he and his metal cage fell from a high-rise building where he and a co-worker were welding tube girts. Each welder was supported in separate metal cages suspended by a steel cable. Each had a portable welding rig on other floors of the building. The victim had his welding lead coming to his work area from above, while his co-worker had his lead coming from below.

The high-amperage cable above the victim's cage was in poor condition, with a damaged and exposed area where the insulation was torn off. The wind made this bare wire come into direct contact with the steel support cable, and in a shower of sparks the welding lead arced to the steel cable, melting both of them in two, sending the cage and the welder to the ground 19 storeys below.

The man inside the cage was wearing a fall protective body harness, rope lanyard and nylon lifeline attached to a point above his work position. However, when the cage fell, it snagged and broke his lanyard, which was in poor condition. His lanyard was attached to the left D-ring of his belt harness, not to the proper attachment point in the midline of his back. He was also not using the leg straps of his body harness, but they were folded upon themselves and taped together.

- Welding leads should always come from below suspended platforms or cages – never from above.
- Welders must inspect welding leads prior to and during work for signs of damage and/or exposed wire.
- Workers should ensure that fall protective gear is in acceptable condition and worn properly.
