# Fall Through Temporary Roof Opening

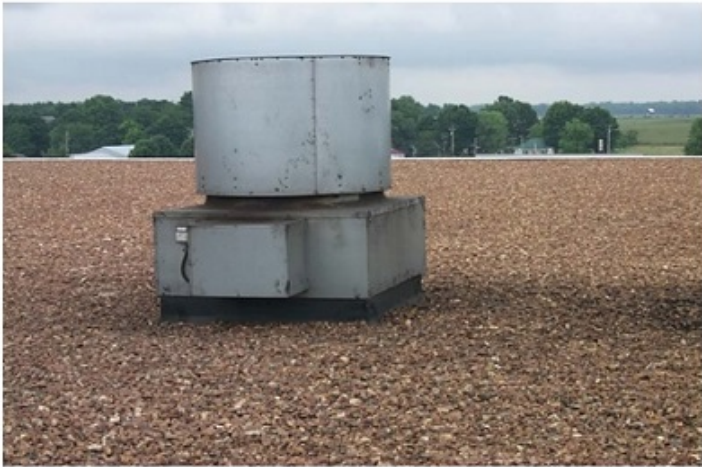
**Exhaust fan had been removed for cleaning, creating a temporary opening where cleaner fell approximately 35 feet/10 meters onto a piece of machinery in the factory.**

A 50-year-old male cleaner died when he fell approximately 35 feet through a temporary roof opening and was impaled on a piece of equipment on the factory floor below. He had been cleaning an exhaust fan with a pressure washer on the factory roof. He and two co-workers had removed the fan from its casing creating a temporary roof opening and set the fan beside the roof opening for cleaning.

Facing the fan with his back to the opening, the cleaner apparently stepped backwards and fell through the opening.

1. Openings in roofs, floors, and walls must be barricaded, protected with a guardrail system, or covered with marked covers to prevent someone from unintentionally falling through them.

a. The employer stated that the factory initially did not want the holes covered up when the fans were removed because it would keep air from flowing out of the factory.

b. After this incident occurred, the company constructed covers of 2 x 4s and plywood nailed together to be placed over the temporary holes in the roof while the fans were removed.

c. Additionally, a moveable four-wall, five-foot-high barricade could have been constructed for the roof openings. This would have allowed the factory air to exhaust through the roof openings while the fans were being cleaned.

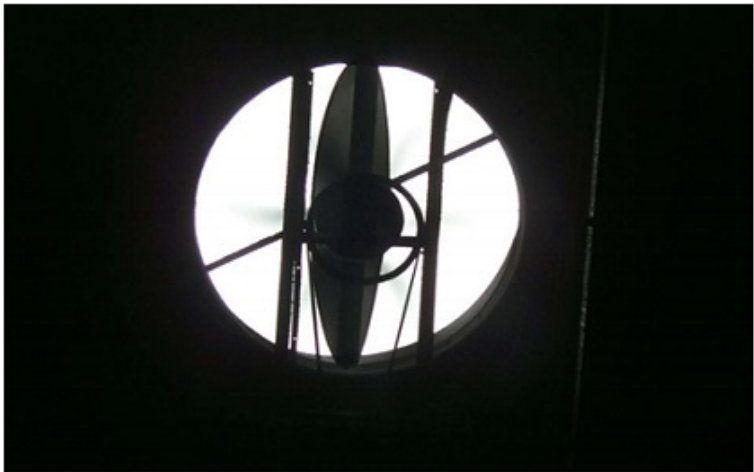
**Exhaust fan above machinery on factory floor.**

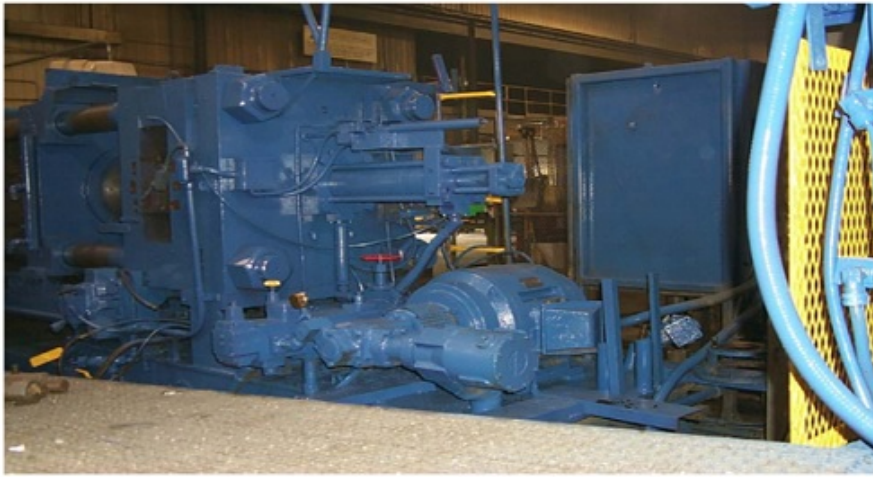
He fell onto a 1200-ton die-casting machine on the factory floor. Onsite personnel working nearby heard the cleaner fall onto the machine. They summoned help and factory-employed emergency response personnel responded to the scene, assessed the situation and called for an ambulance. Local emergency medical personnel and police arrived at the scene and contacted the coroner. The coroner arrived and declared the

**Machinery victim fell on.**
