# Ground Water Problem Not Communicated

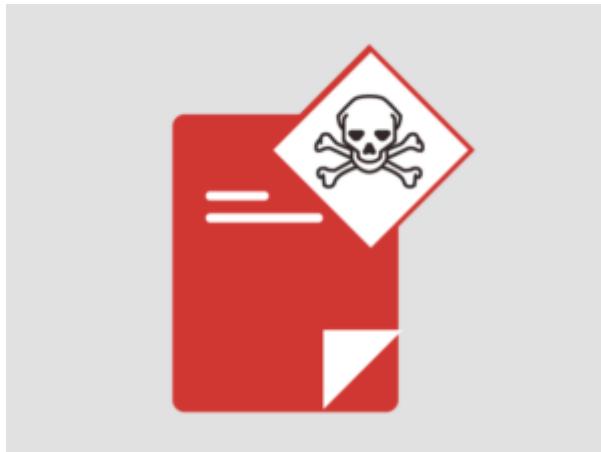
One member of the crew was last seen standing directly in front of a backhoe. It was a dangerous place to be, and his co-workers did not know why he was there. The backhoe was digging a trench with vertical, rather than sloping, walls making them unstable. The ground collapsed and the worker was buried by the dirt.

*A number of things went wrong to create this situation, including poor communications. Information about possible job hazards must be communicated and discussed at all levels so appropriate precautions can be taken. Safe trenching techniques of sloping, shoring and barricading will help prevent fatalities such as these. Fall arrest equipment should be worn anywhere there is danger of falling or engulfment by moving materials to prevent injuries and aid in prompt rescue.*
