# Material Storage: Pallets, Racks, Overlots and Falling Objects Picture This

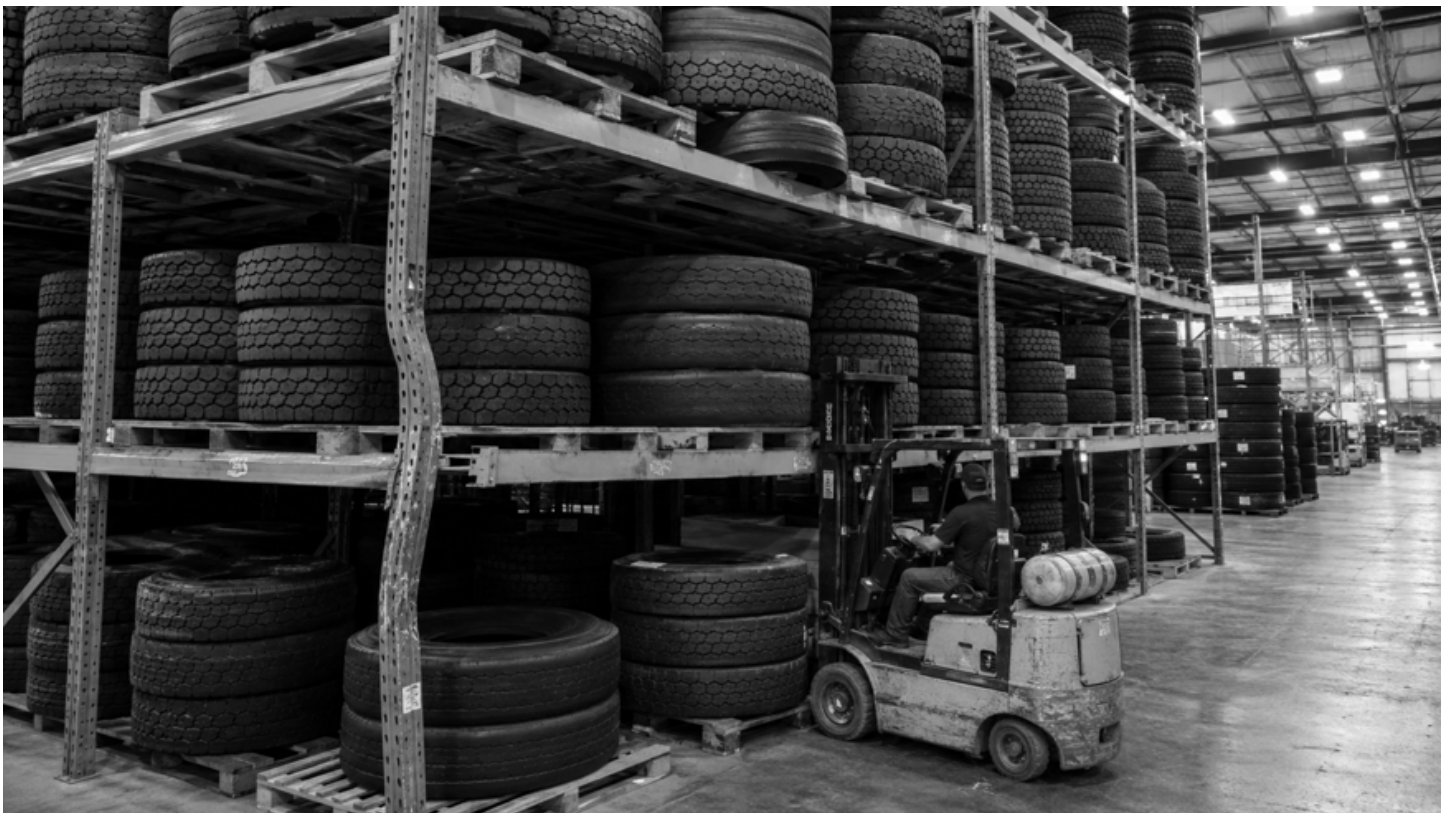
This image shows the interior of a large tire distribution warehouse during an active shift. A forklift operator is working in a storage aisle beneath a three-tier pallet rack system loaded with heavy industrial truck tires stacked well above the 16-foot limit. The rack's vertical uprights show visible damage – a bent upright on one side, scuff marks consistent with prior forklift impacts. The horizontal beam locks on the middle tier are missing on one side, leaving the beam unseated. The pallets on the upper tier are unbanded, with tires stacked unevenly and slightly overhanging the edge. The operator below is focused on retrieving a pallet at ground level, positioned directly beneath the compromised upper tier.

Nothing in this image looks like an emergency in progress – and that is the most dangerous part. The rack has been damaged before. The beam locks have been missing for some time. The overheight, unbanded load has been sitting there through multiple shifts. Each day that passes without an inspection or a repair normalizes the hazard, until the moment the structure can no longer hold and a worker underneath pays for every ignored warning sign. Damaged racks must be reported, tagged, and taken out of service immediately – not at the end of the shift, not after the next delivery. The load does not wait for a convenient time to fall.
