# Scaffold Safety Fatality File

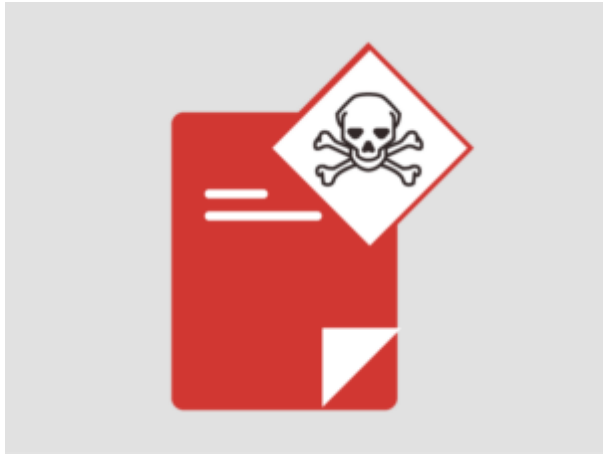
A 37-year-old male painter died when the platform he was working from fell 65 feet inside a municipal water storage tank. The victim was a member of a three-man crew that was using an improvised suspension scaffold to paint the interior of the 68-foot-tall, 32-foot-diameter water tank. The scaffold consisted of an aluminum ladder used as a platform and secured to steel “stirrups” made of steel bar stock bent into a box shape and attached to each end of the ladder. Wire cables from each stirrup ran to a common tie-off point. A cable from this common tie-off was rigged to a block and tackle used from ground level to raise and lower the platform. The block and tackle supporting the system was secured to a vertical steel pipe on top of the tank with a cable that was fashioned into a loop by U-bolting the dead ends of a piece of wire rope.

Investigation of the incident revealed that the two U-bolts on the loop of cable supporting the block and tackle had loosened enough to allow the cable ends to slip through, causing the scaffold to fall. This particular rig had been used without incident every day for 2 weeks preceding this fatal fall.
