# Steel Walkway Contacts 14,400 Volts

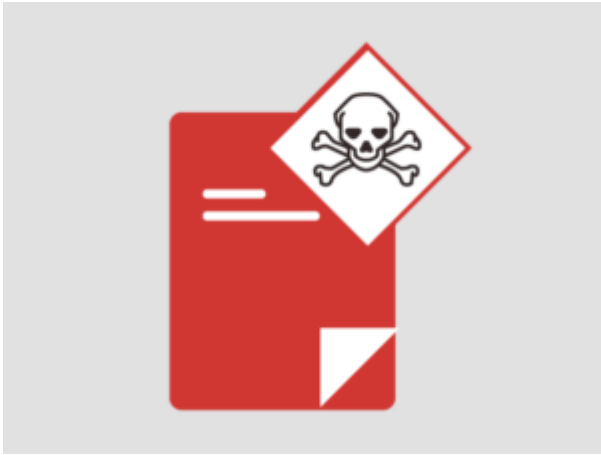
A worker attaching wire rope slings to a walkway was electrocuted when a crane operator swung the main boom of the crane over a walkway.

The 56 foot steel walkway was to be used for access to a marine float. When the crane operator had swung the main boom over the walkway, the main lifting line contacted an overhead primary power line, which carried 14,400 volts. The contact energized the lifting line, slings, crane and walkway. One of the workers who was holding a sling cable was electrocuted.

A co-worker heard the victim groan and saw him clutching the sling to his chest. He saw electrical sparks coming off the slings hanging over the steel railings of the walkway. Looking up, he saw the lifting line had contacted the power line. Two co-workers were unhurt: the foreman because he was insulated by the wooden decking on the steel walkway, and the crane operator who was protected because of the non-conductive rubber tires on the crane.

Later investigation disclosed burn marks which traced the path of the electricity from where the lifting line touched the power line, the wire rope slings touched the walkway, and the walkway touched the ground.

*The power company was not informed of this job ahead of time. Whenever you plan to work near a power line, contact the power authority so power can be shut off or the lines guarded. You can also discuss safety precautions. When it is not possible to shut off power, use a "spotter" to warn the operator of the proximity of overhead wires. Always keep the maximum safe distance away from energized power lines. Know and understand your "limits of approach." Electrocutions involving power lines and equipment such as cranes, poles, pipes and ladders are all too common.*
